REPORT NO. 3542

ST. LOUIS-SAN FRANCISCO RAILWAY COMPANY

IN RE ACCIDENT

Accident near Edward, Kans., on October 24, 1953, caused  
by a broken rail.

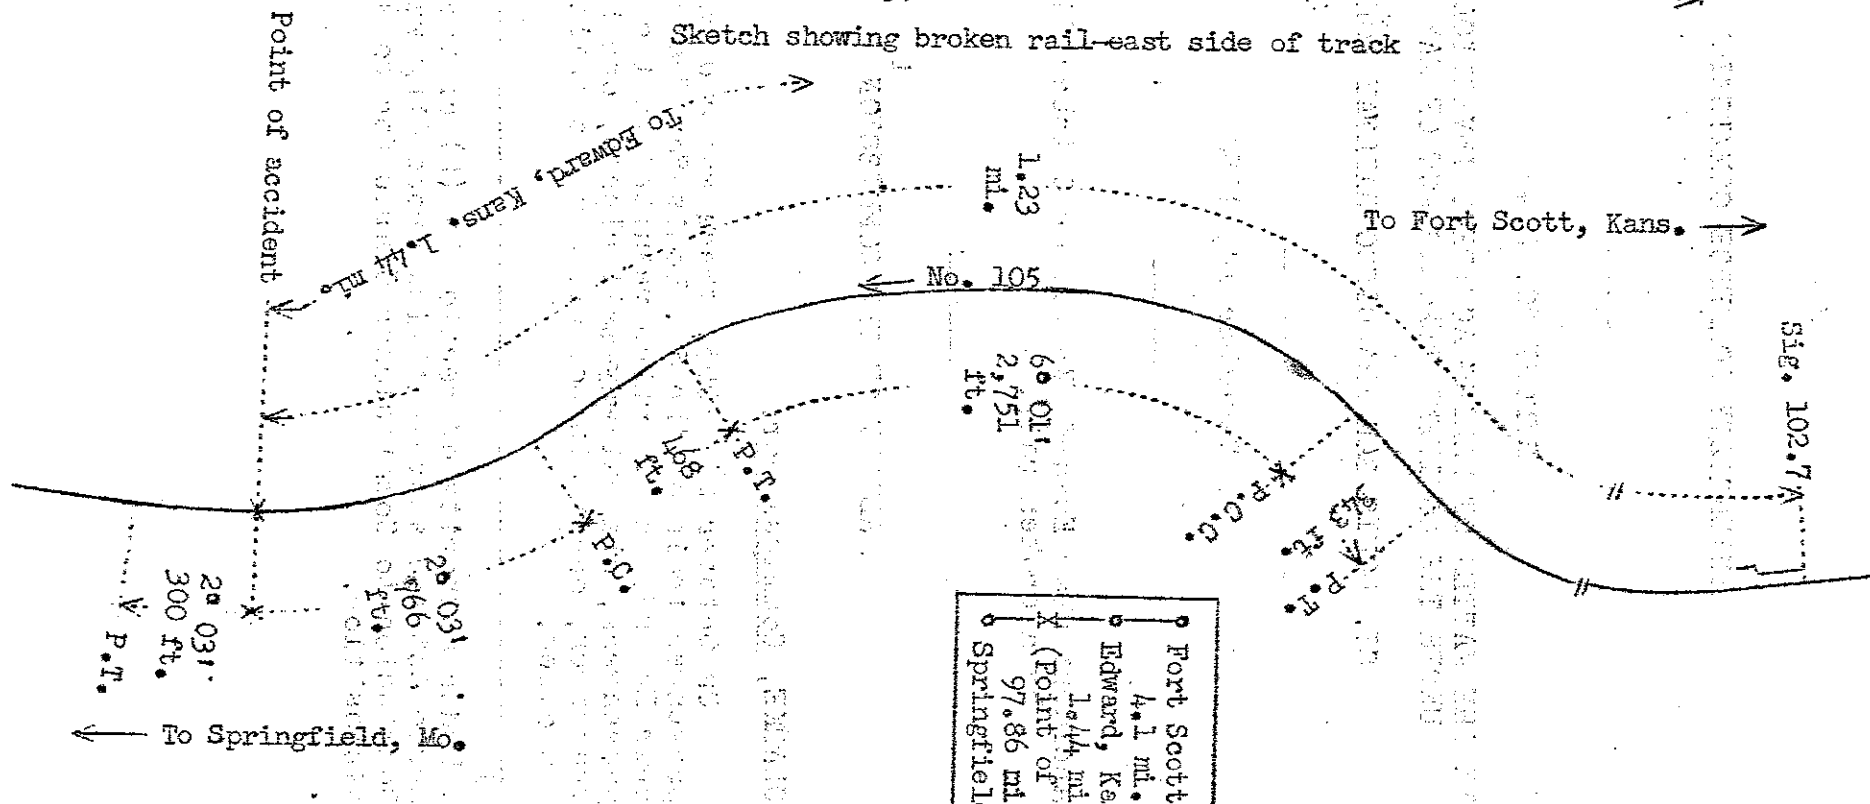
Sketch showing broken rail—east side of track

After the accident occurred a broken rail was found in the east side of the track. This rail was rolled by the Tennessee Coal and Iron Division of the United States Steel Company in August, 1930. It was broken into many pieces, 12 of which were recovered. The first three breaks occurred at points, respectively, 3 feet 3 inches, 5 feet 5-3/4 inches, and 7 feet 4-3/4 inches south of the receiving end of the rail. Each of these breaks occurred between ties. Examination of the rail disclosed that prior to the time of the accident transverse fissures had existed in the head of the rail at the first break and at the third break. The fissure at the first break covered 10 to 12 percent of the area of the head, and the fissure at the third break covered 18 to 20 percent of the area of the head. Neither fissure extended to the surface of the rail, and neither could be detected by visual inspection. Apparently the rail was broken under the front portion of No. 105. After the first break occurred, evidently the broken end was struck with sufficient force to cause the second and third breaks, and a broken piece of rail was dislodged.
